**O & M INSPECTION REPORT
FOR NAVIGATION AND SHORE PROTECTION PROJECTS**

1. Project Name: Hilo Deep Draft Harbor

2. Date of Inspection: May 3, 2004

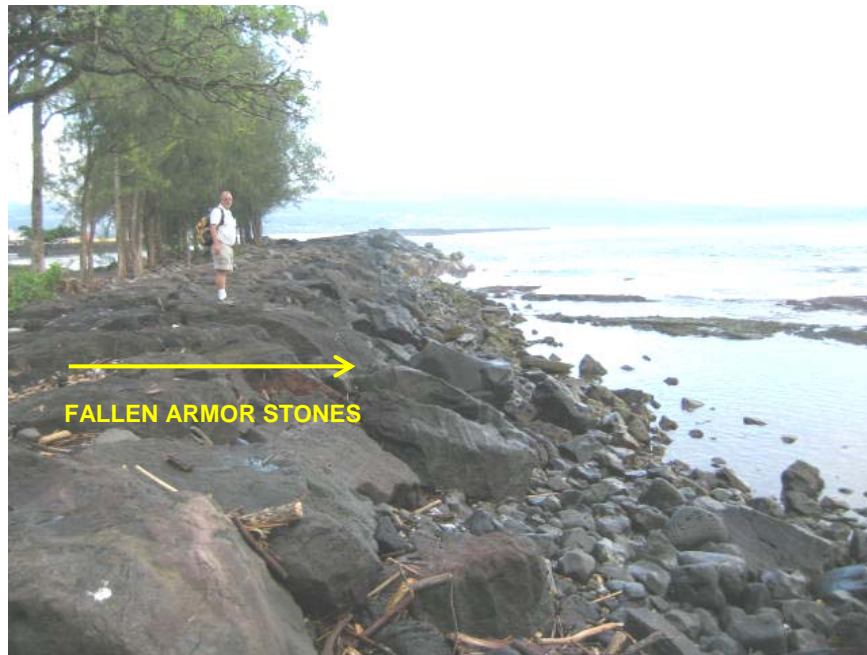
P1. Sta. 0+50, OS, Armor stones dislodged from hinge and resting on sideslope

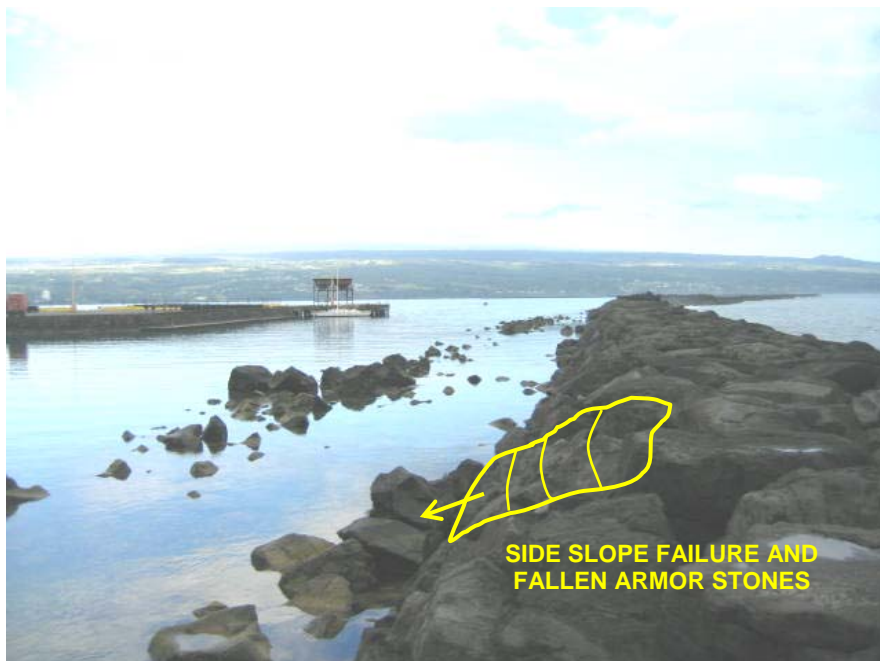
P4. Sta. 4+00, Harbor Side Failure of Side Slope, monitor.

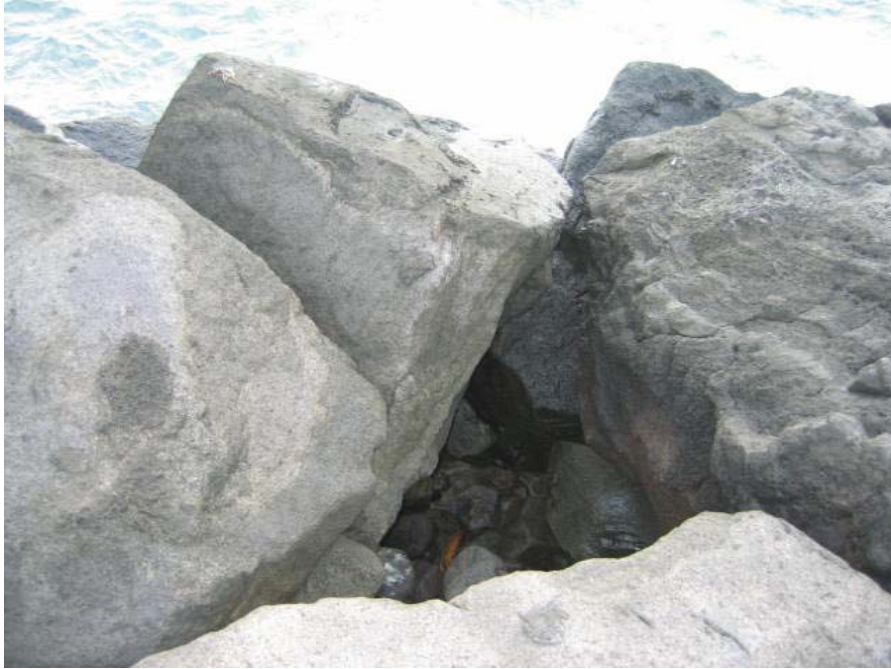
P5. Sta. 8+15, Void on OS of crest

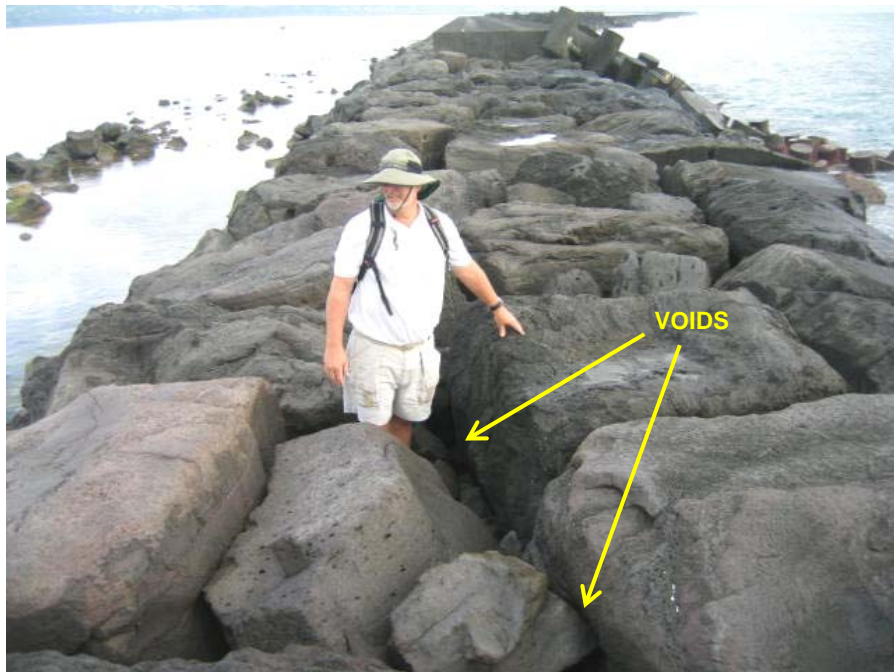
P6. Sta 10+05, Two voids at centerline of crest

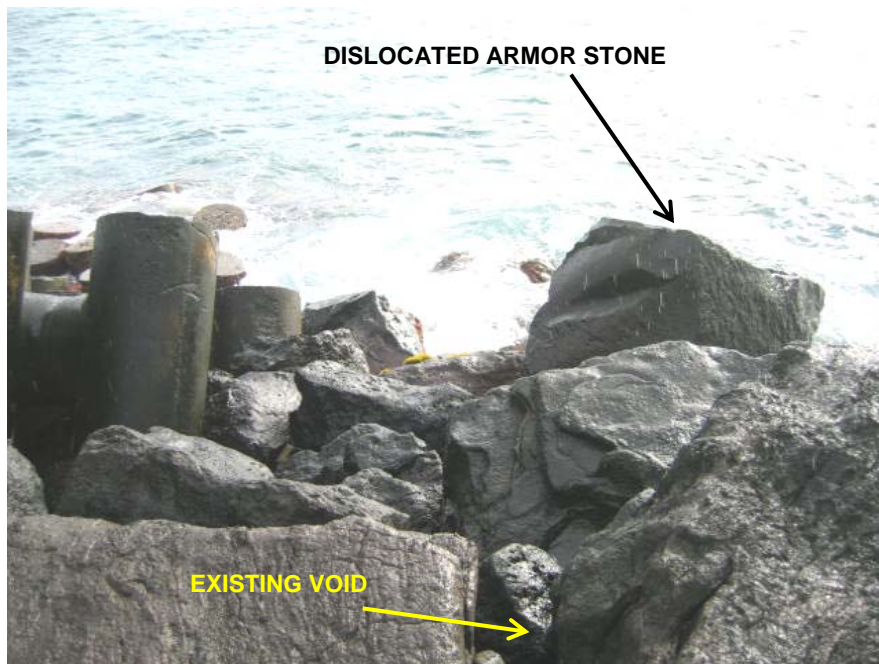
P7. Sta. 10+75, OS, Monitor dislocated armor stone resting on the sideslope.

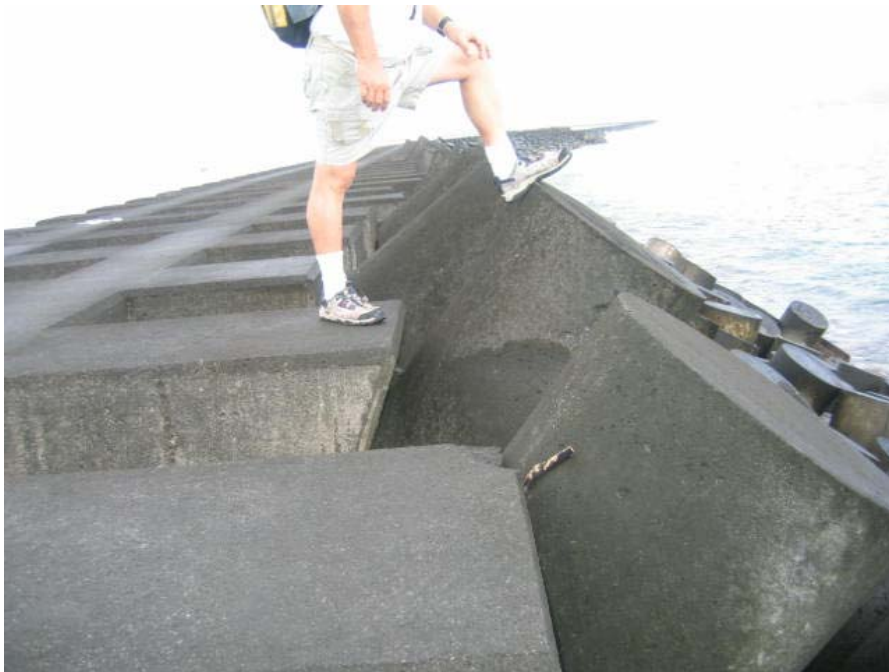
P12. Sta 11+55, OS, 1" separation (tribar #735).

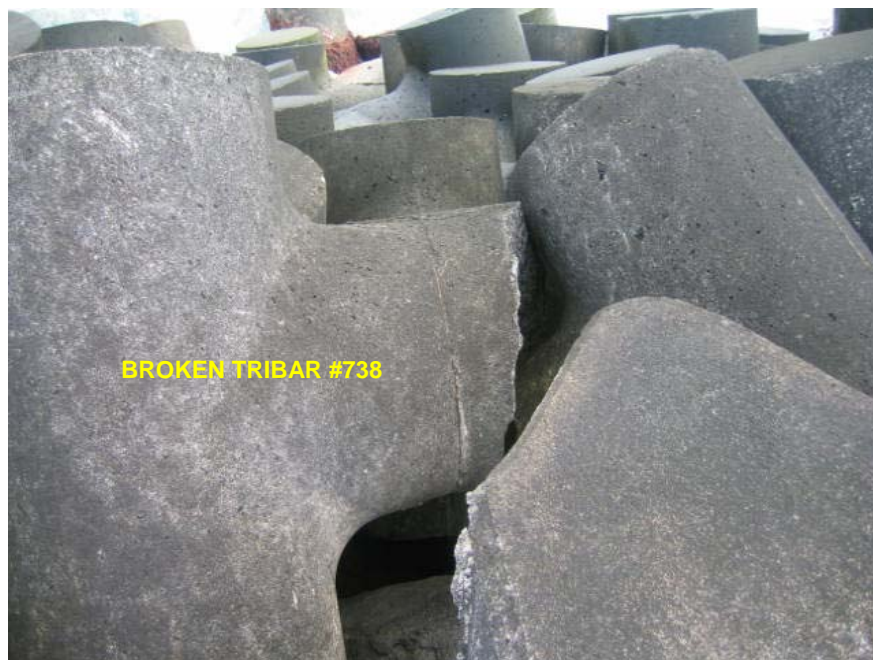
P14. Sta. 13+10, OS, Broken Tribar # 738

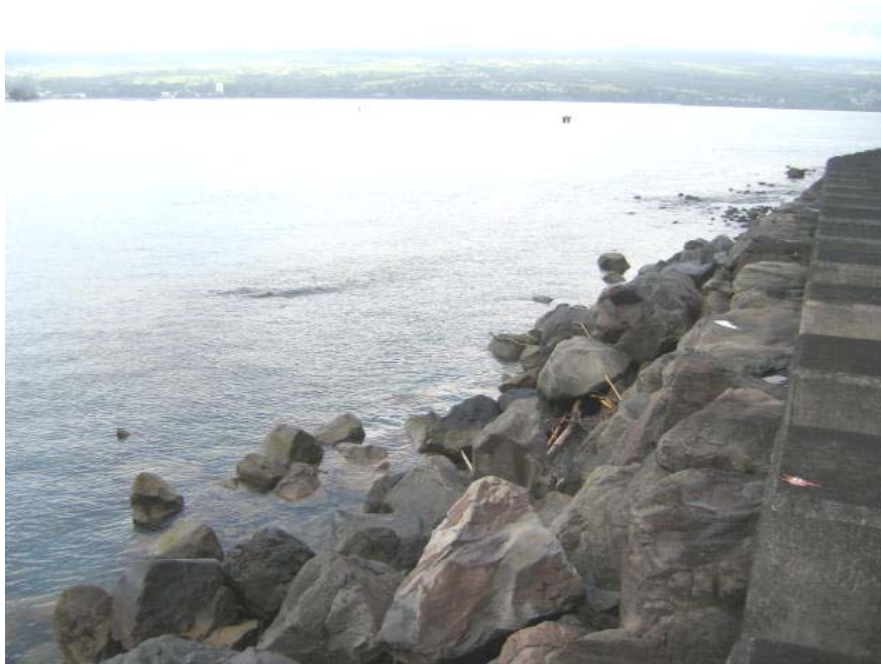
P15. Approx. Sta 14+00, Peeling of stone on HS, see post-storm report

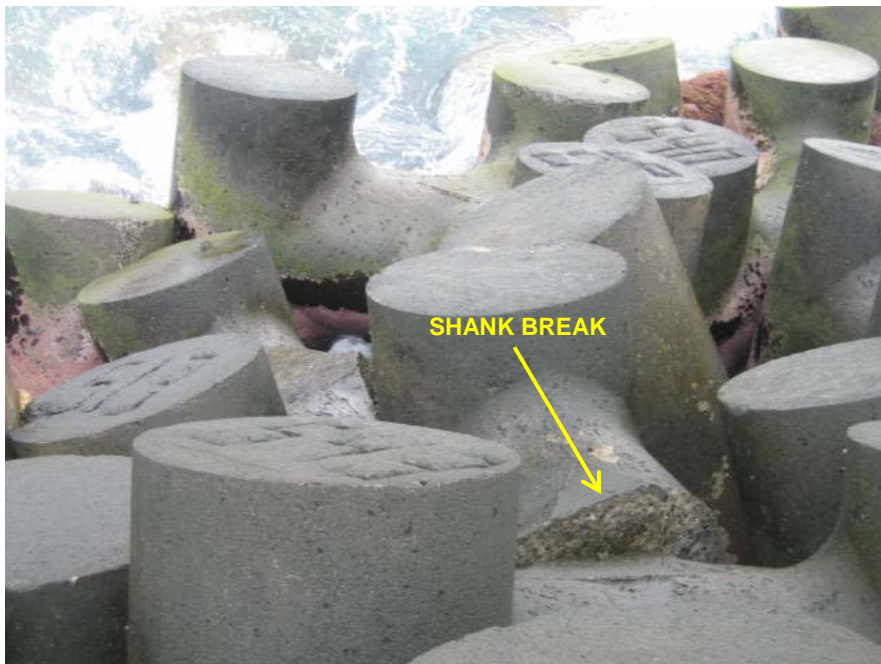
P16. Sta. 14+84, OS, Shank Break.

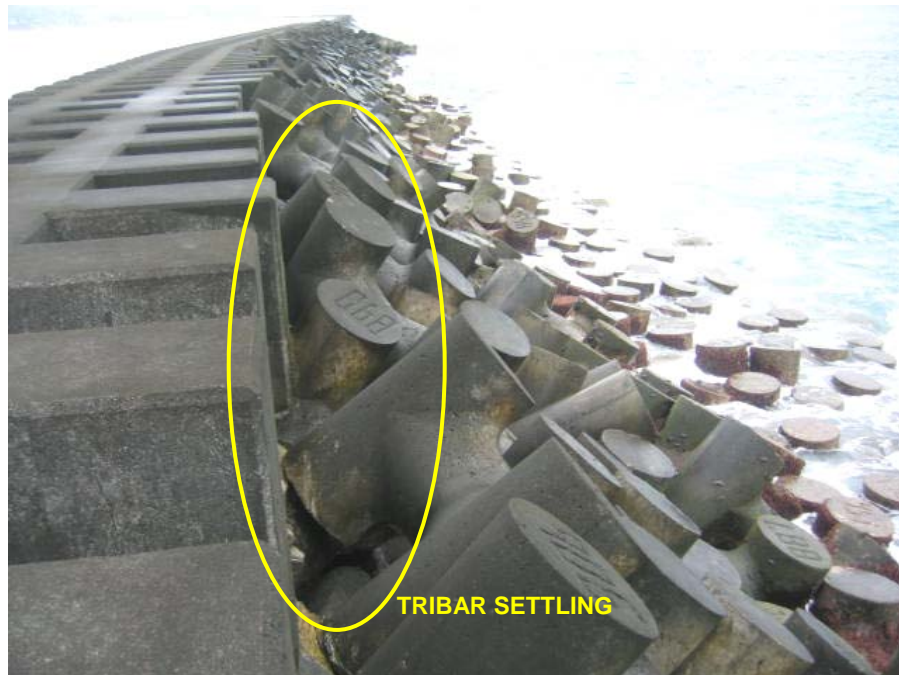
P17. Sta.15+30 to 15+56, OS, Monitor tribar movement.

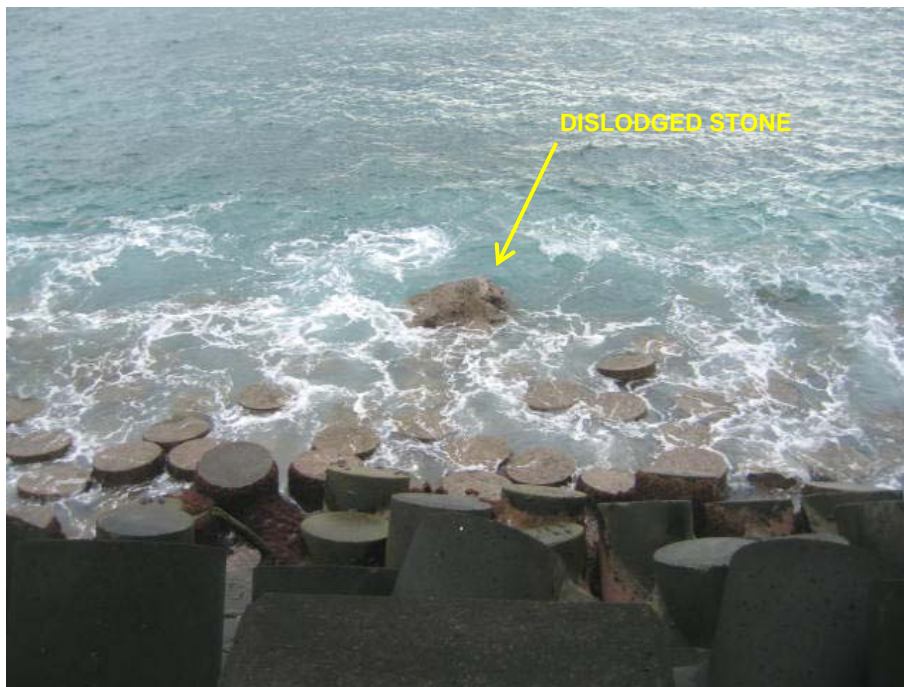
P18. Sta 15+32, Dislodged stone at ocean side toe

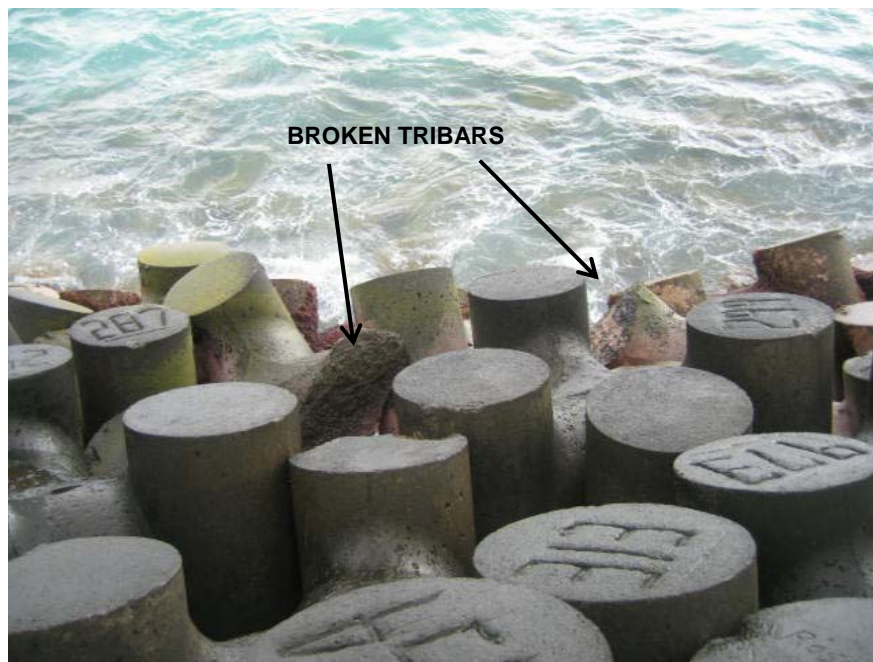
P20. Sta. 17+40, OS, Broken Tribars # 317 / 287 / ?

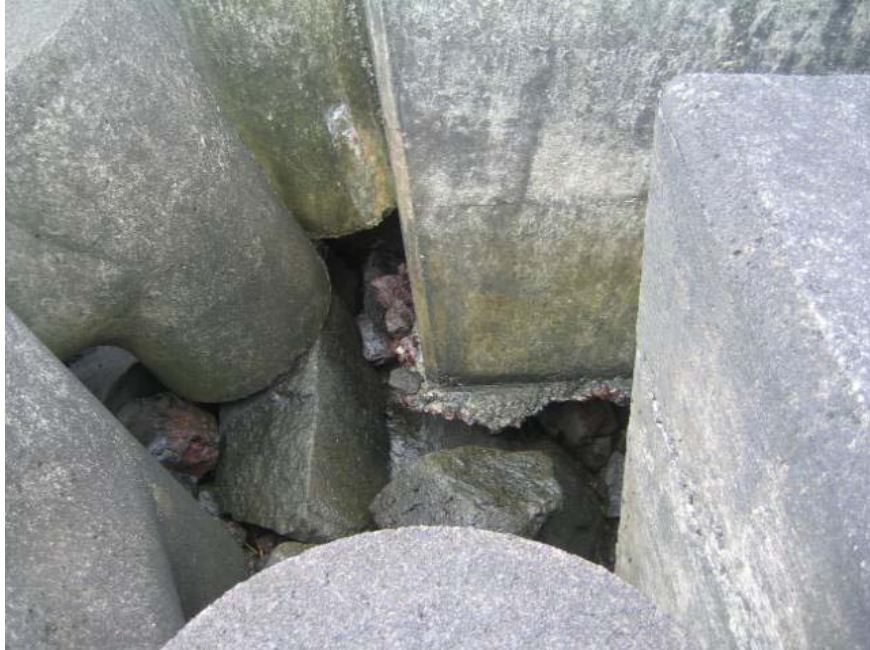
P21. Sta. 18+56, Settling under tribar ribcap, monitor.

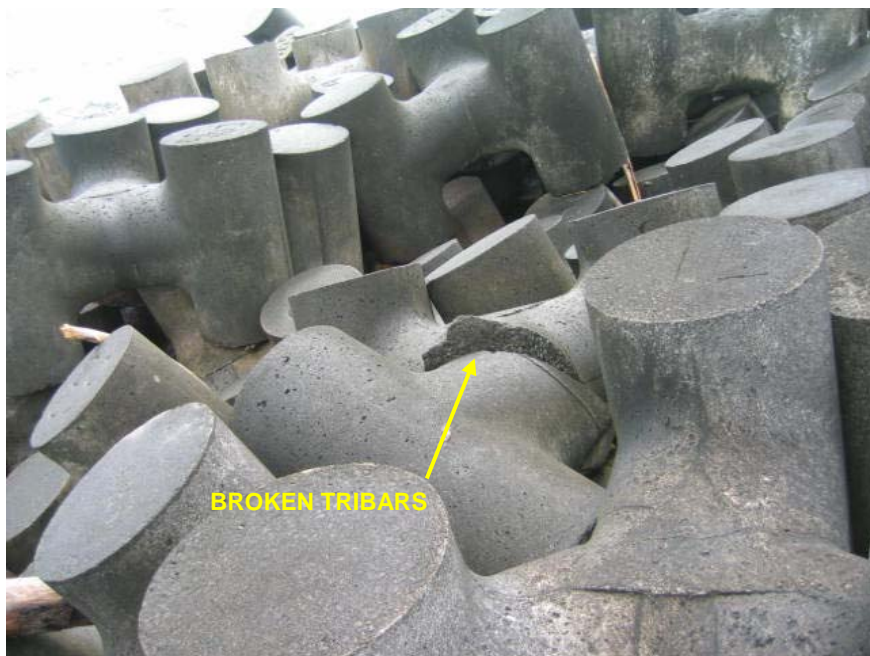
P22. Sta. 19+52, OS, Broken Tribar # 64

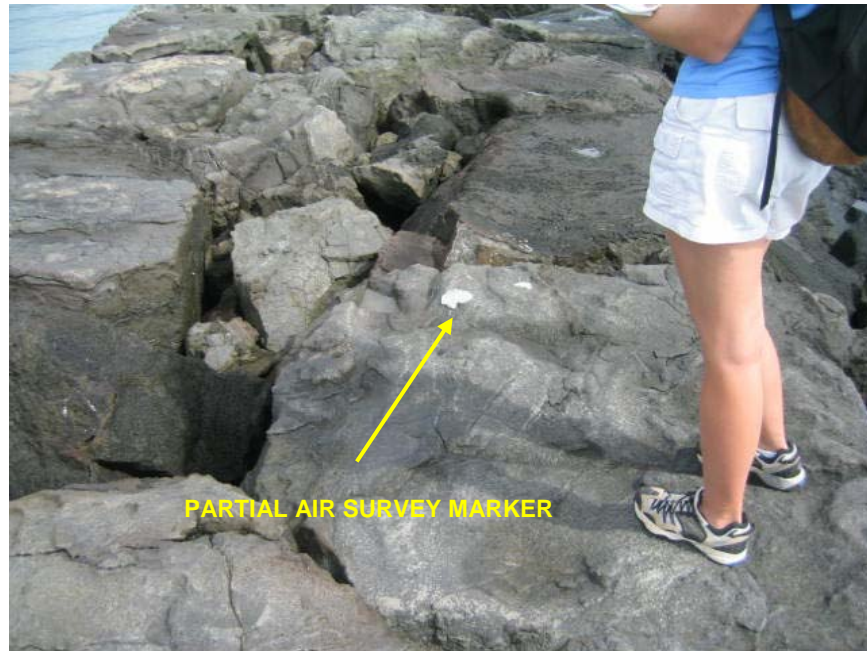
P23. Sta 21+90, Partial Air Survey Marker

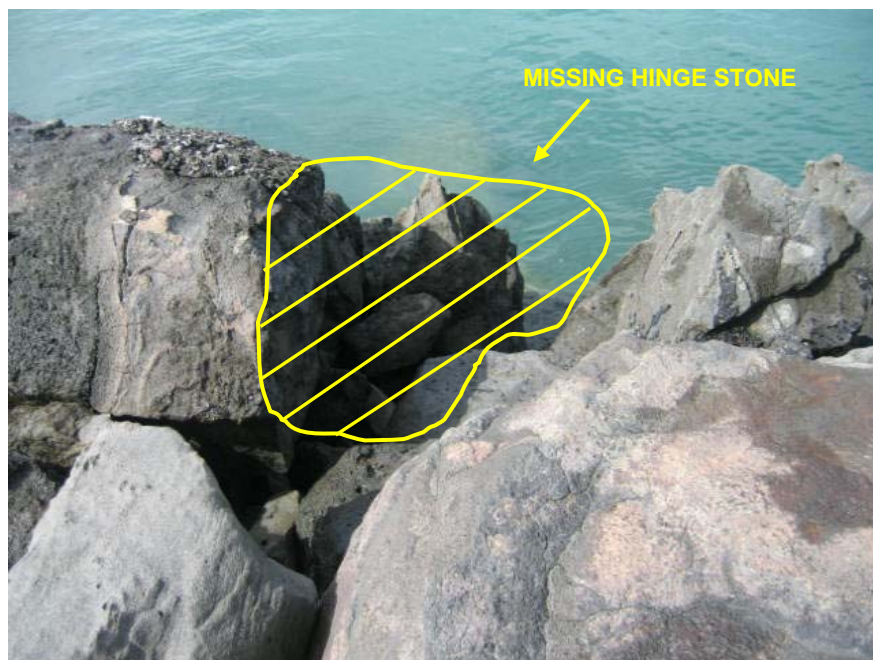
P24. Sta 22+80, Missing harborside hinge stone

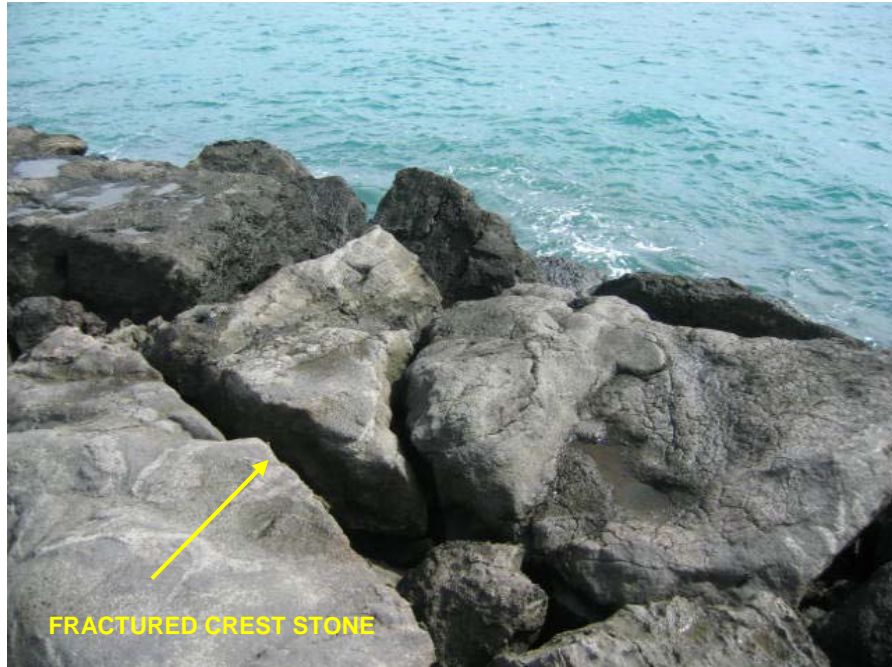
P25. Sta 22+90, Fractured crest stone

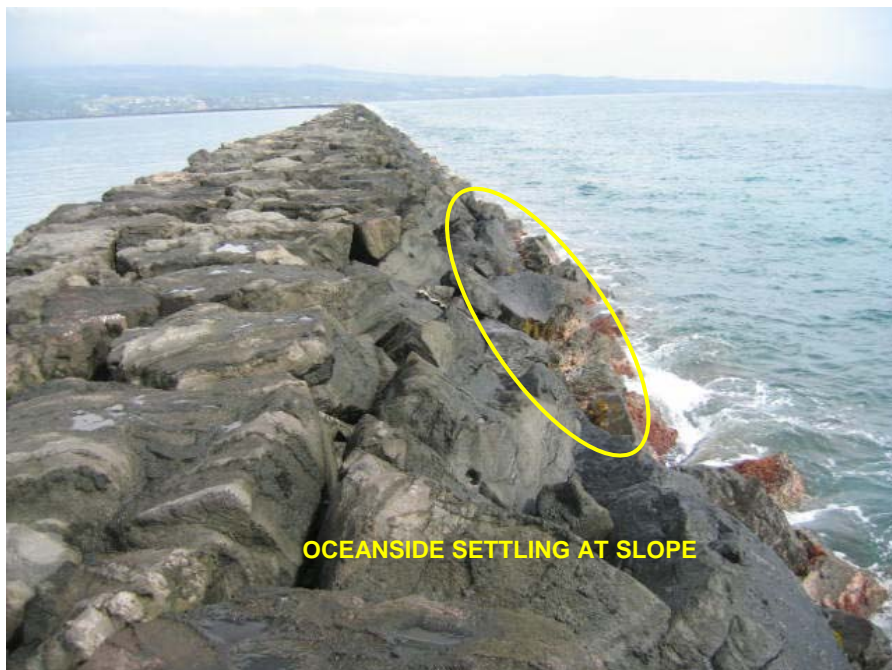
P26. Sta 23+90, Oceanside settling

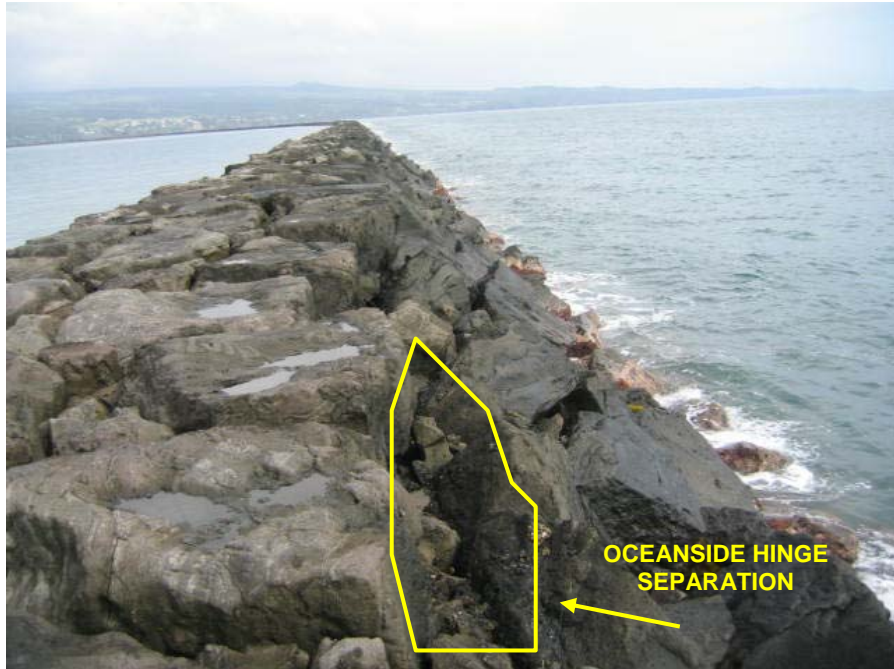
P27. Sta 25+00, Oceanside hinge separation

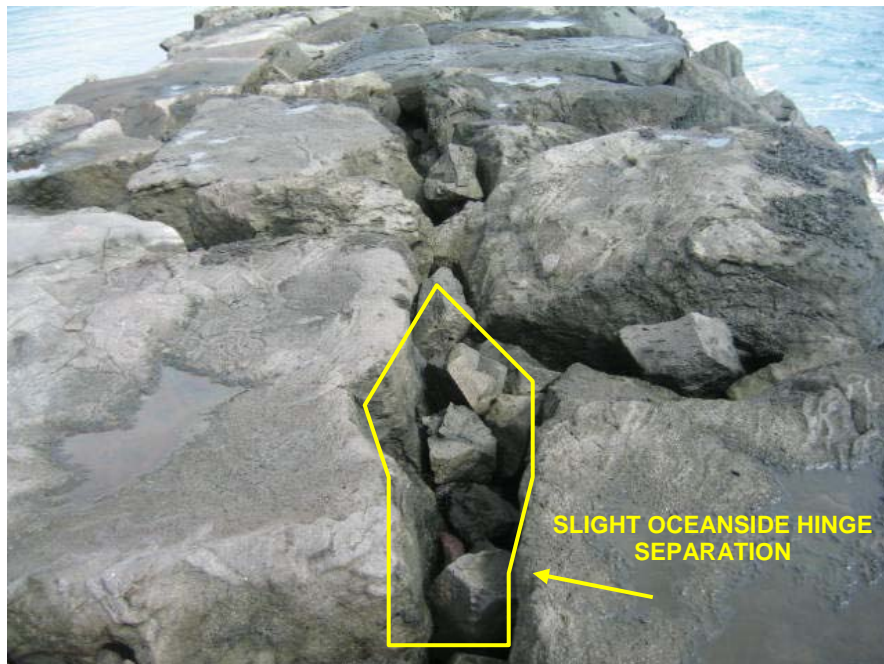
P28. Sta 25+30, Slight separation at Oceanside hinge

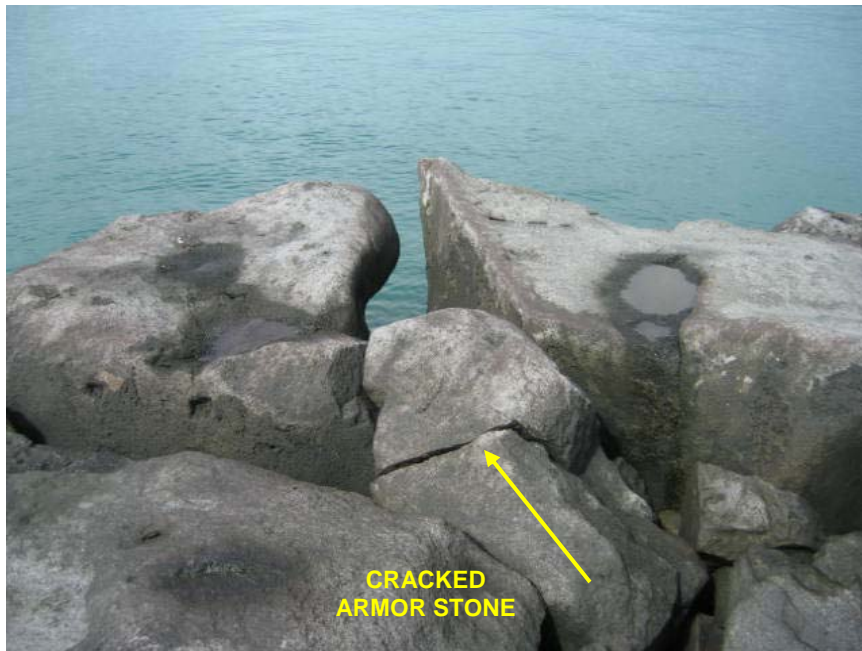
P30. Sta 26+49, Cracked armor stone on harborside hinge

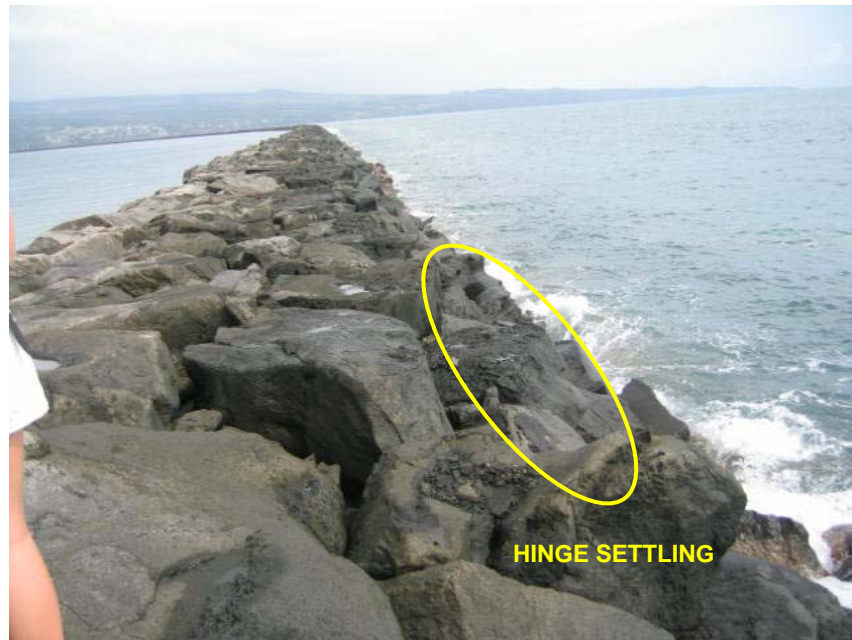
P31. Sta. 27+28, OS, Monitor hinge settling.

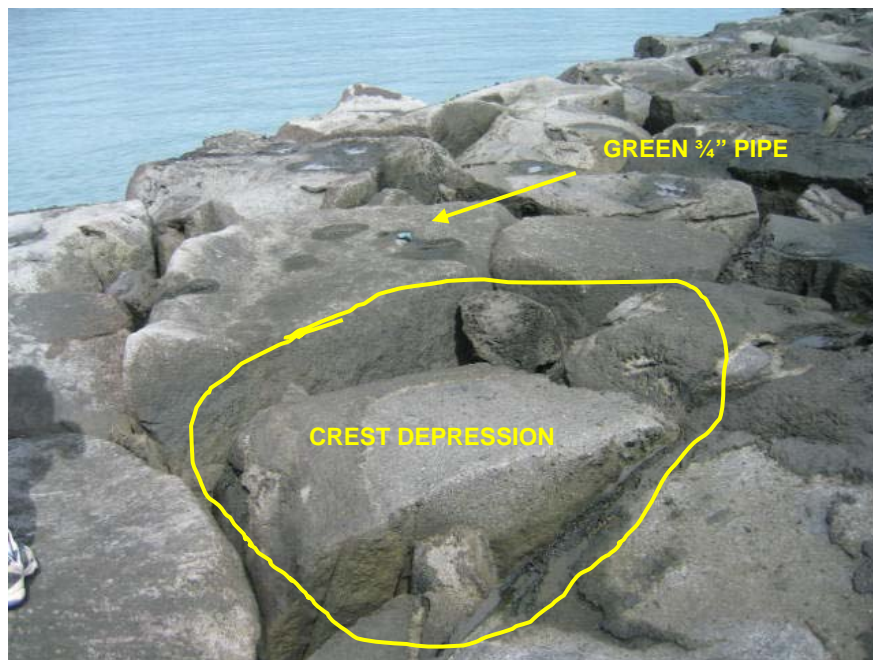
P34. Sta. 29+38, Depression on crest

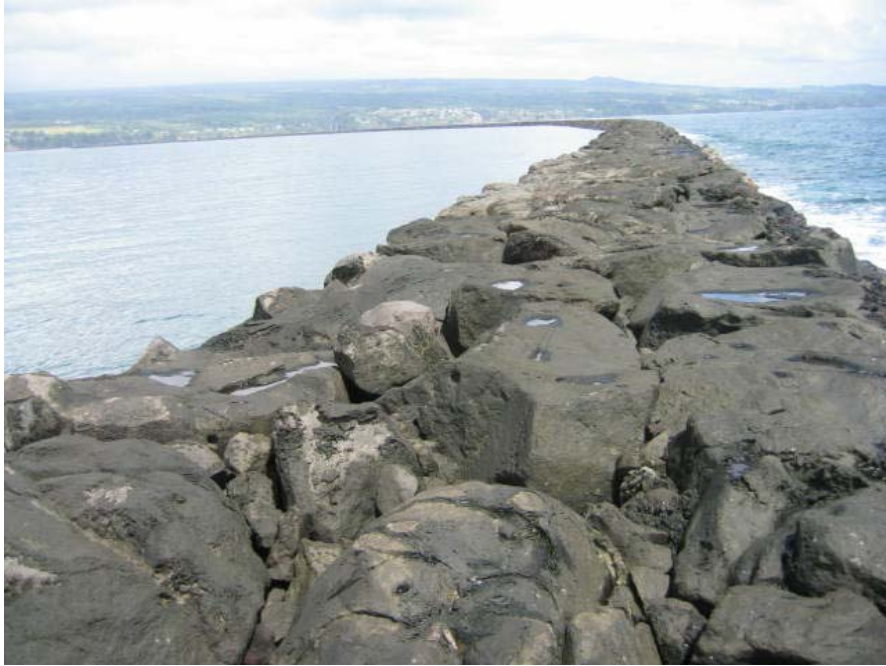
P43. Sta 40+55, Bridging and settling at crest

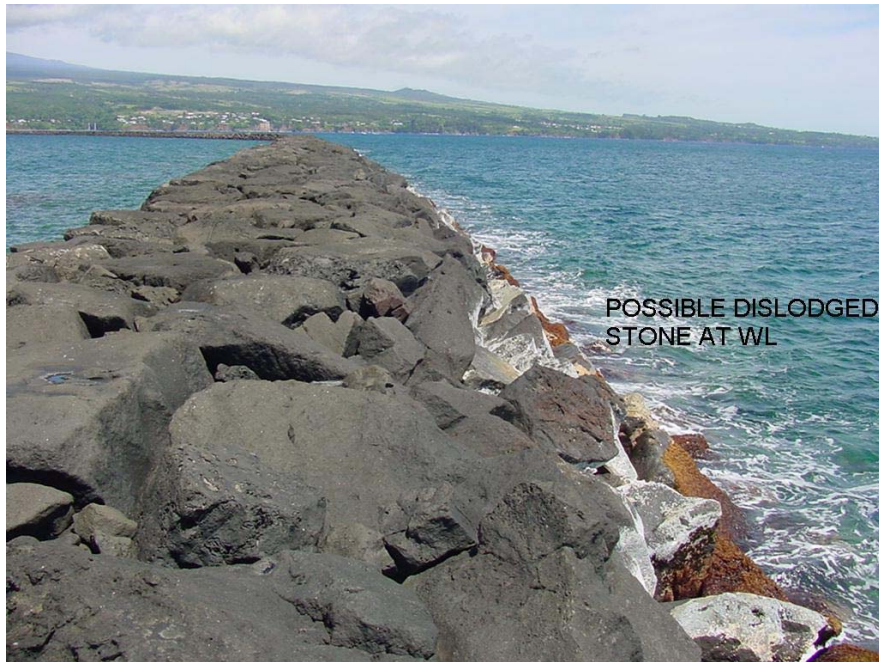
P44. Sta. 42+50, OS, Possible dislodged stone at WL. (2003 photo)

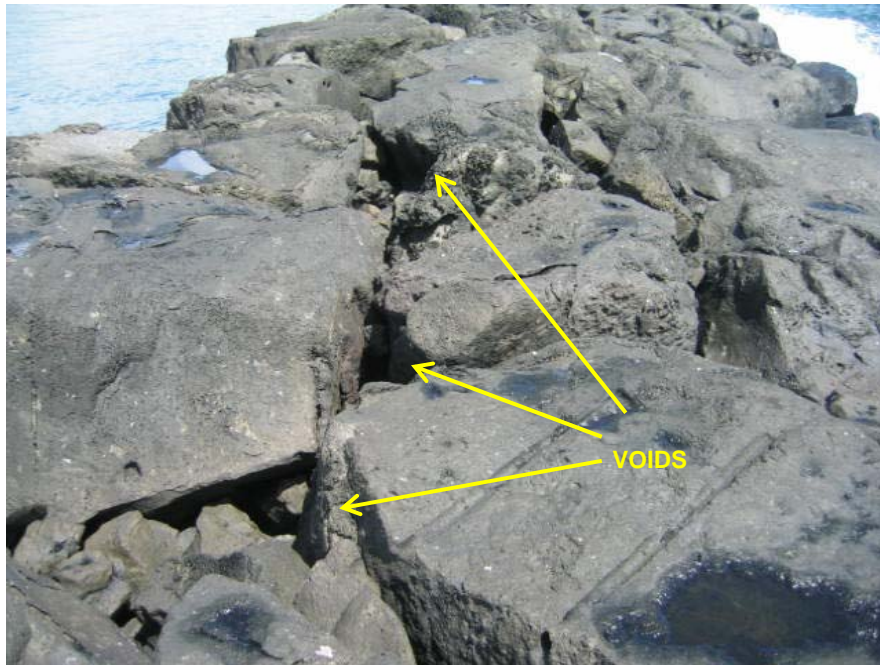
P45. Sta. 43+80, 3 Voids and armor stone separation.

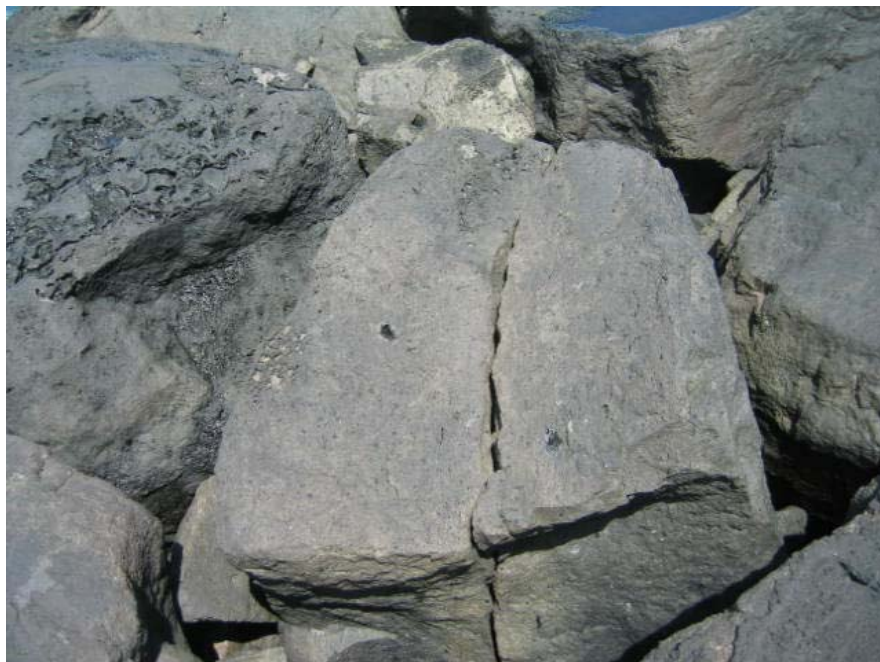
P46. Sta. 48+29, Split armor stone.

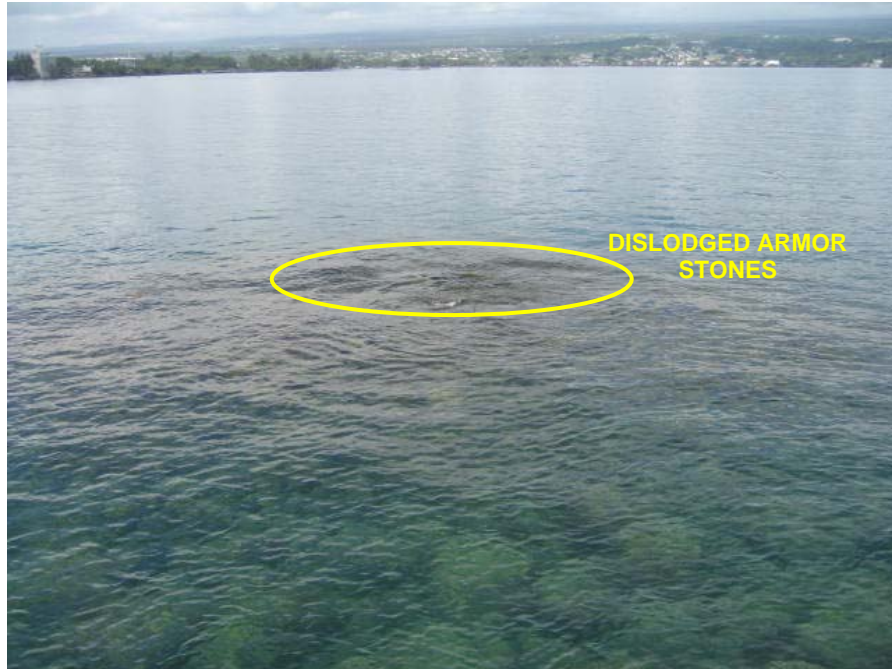
P47. Dislodged armor stones on harborside, 25 ft from structure.

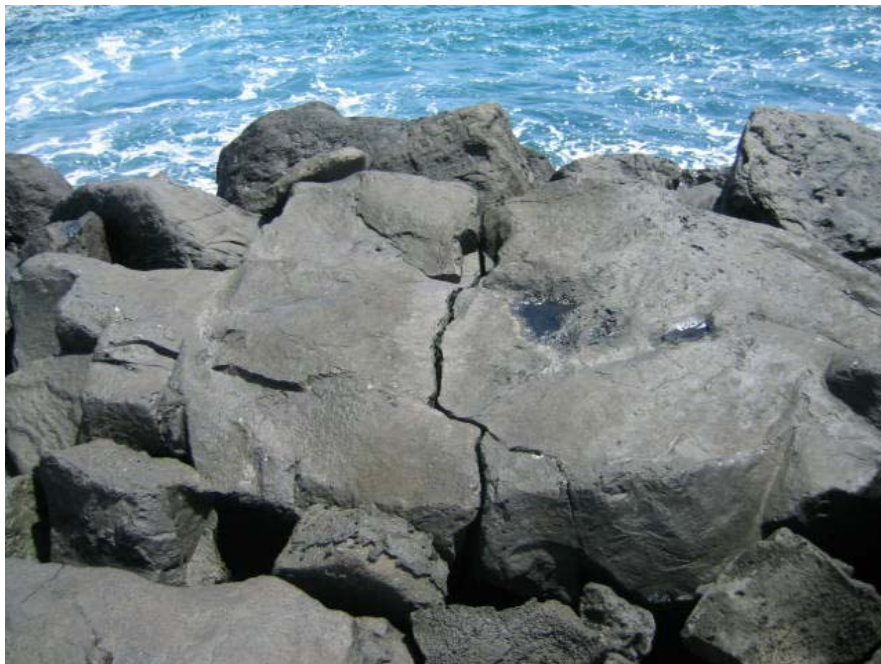
P48. Sta. 49+15, OS, Cracked armor stone at hinge.

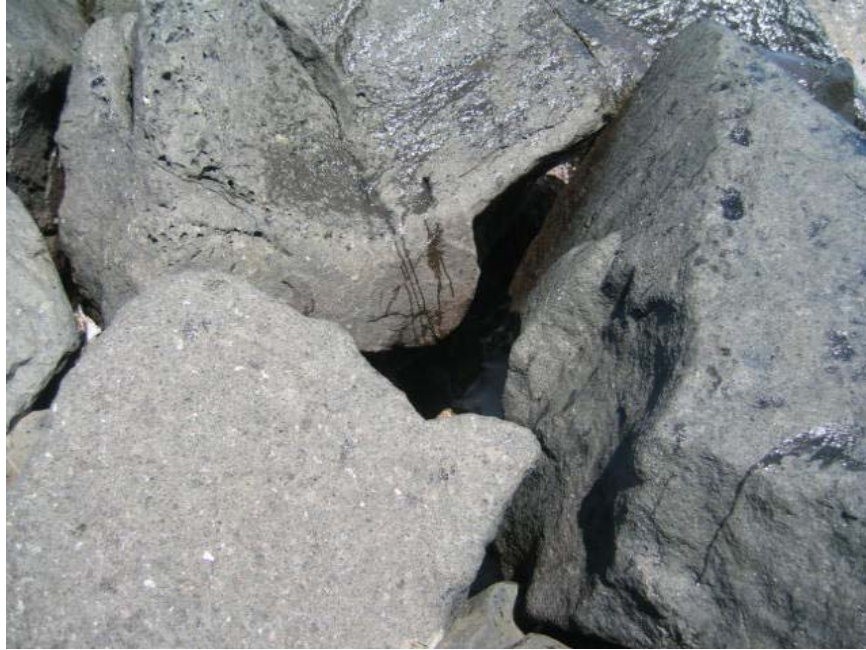
P49. Sta. 52+60, Bridging of crest stone.

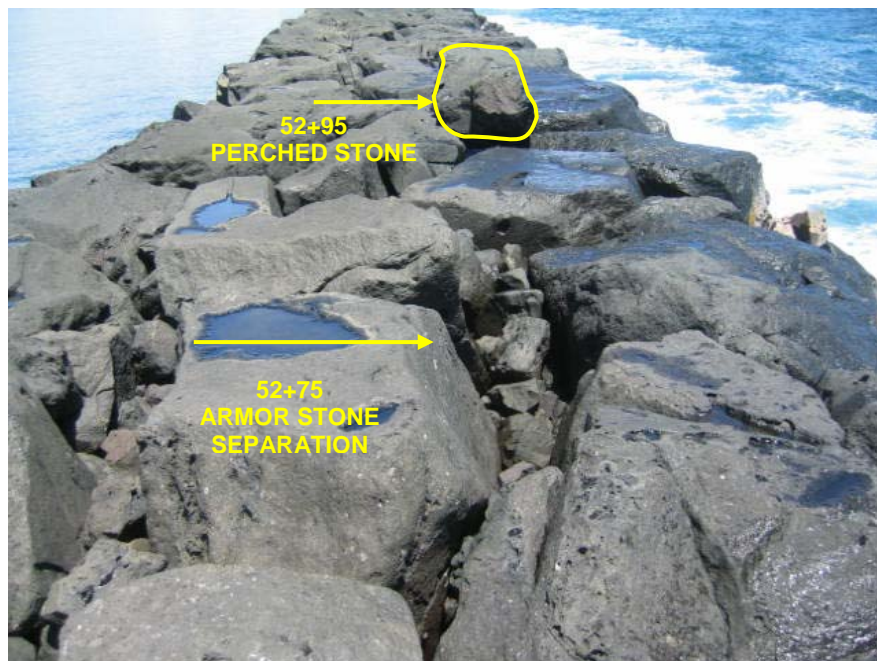
P50. Sta. 52+75 to 52+95, OS, Perched armor stone resting on the crest. Separation of crest due to wave forces with rocks being tossed up from the ocean and wedging between the armor stone's contact keeping them apart.

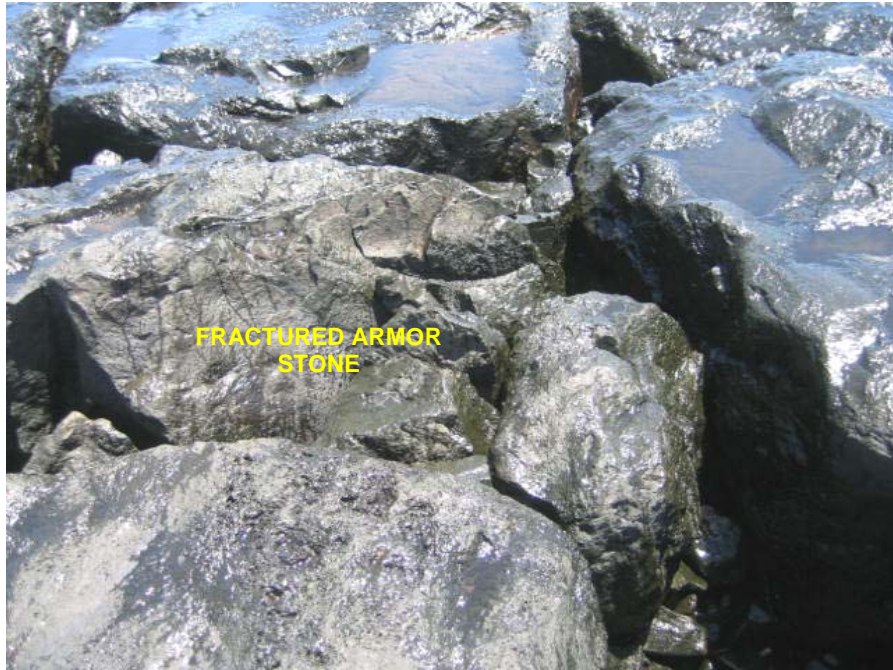
P51. Sta. 54+00, Fractured armor stone at crest.

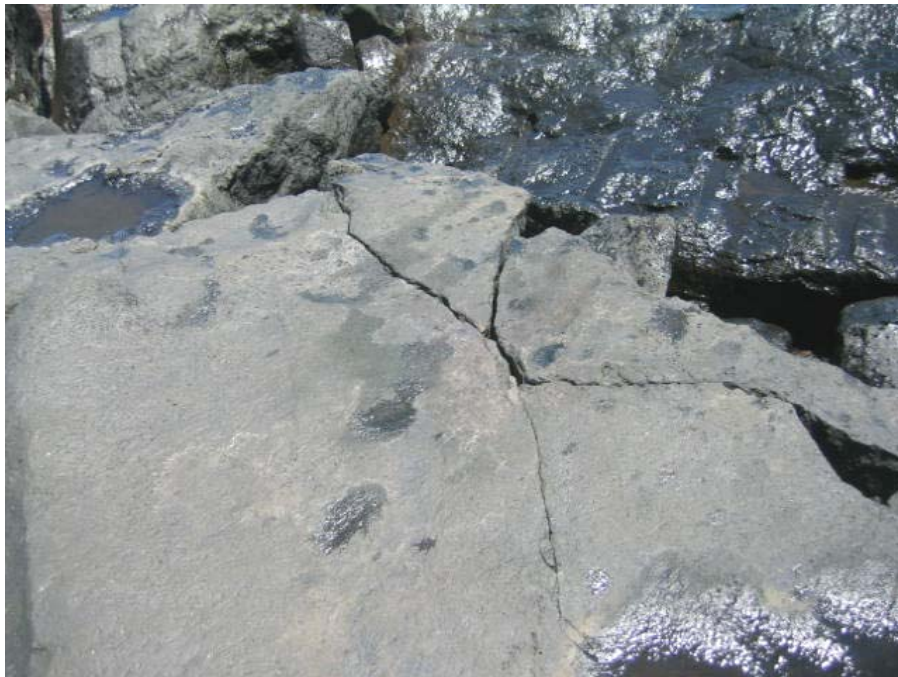
P52. Sta. 54+30, Fractured armor stone at crest.

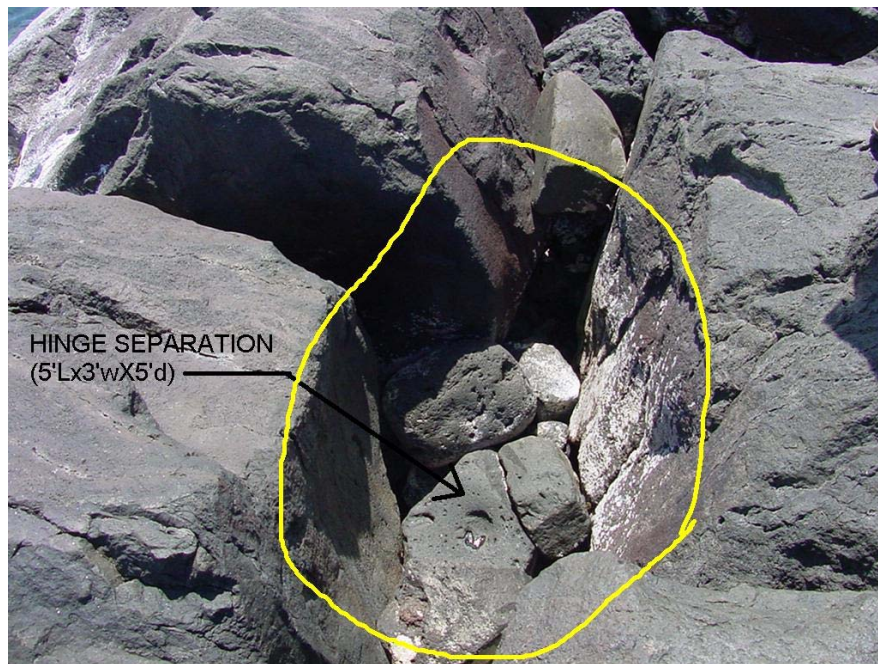
P53. Sta. 54+50, Crest, Hinge separation w/ void 5'L x 3'W x 5'D. (2003 Photo)

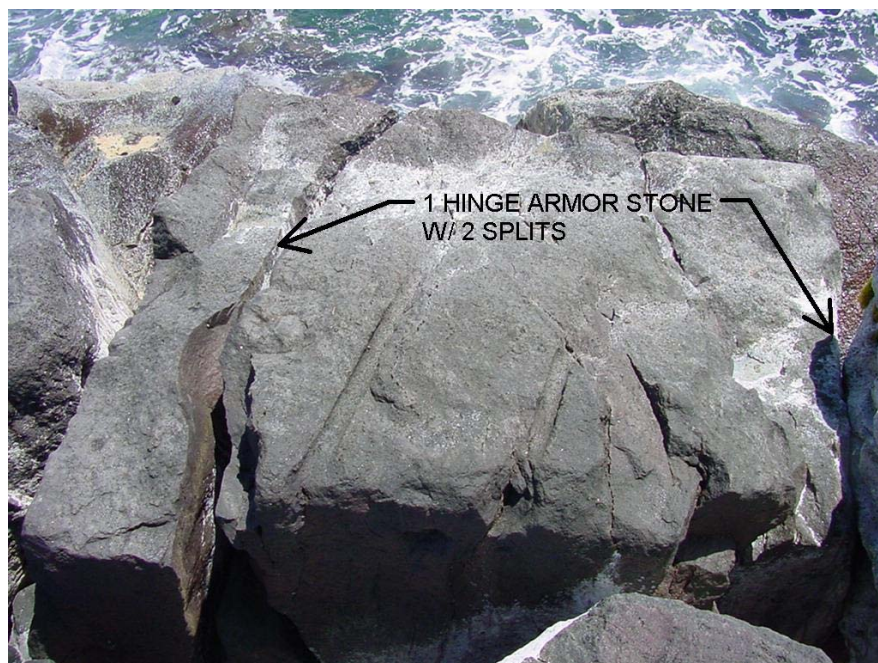
P54. Sta. 54+75, OS, 1 armor stone at hinge with 2 splits. (2003 Photo)

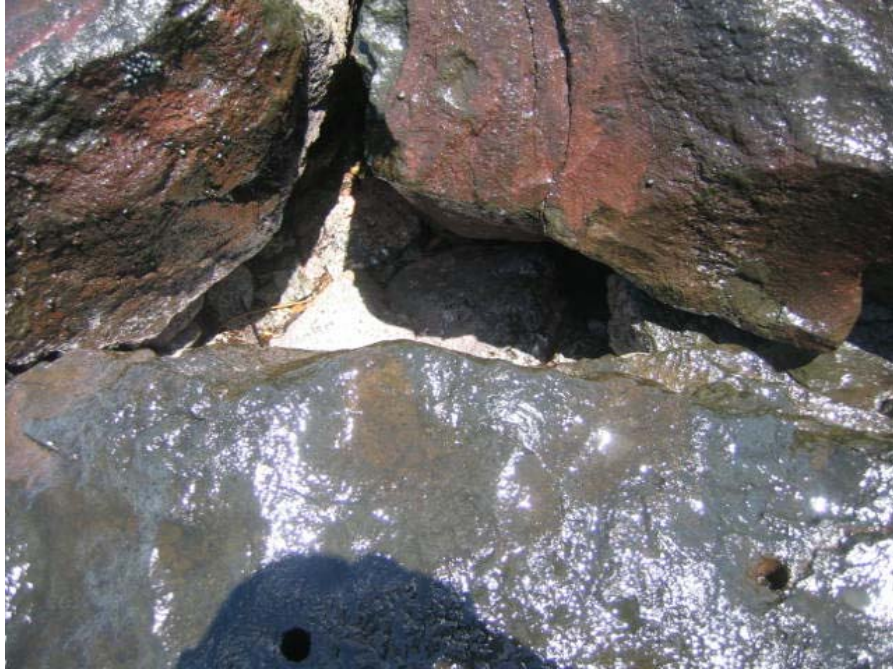
P55. Sta. 55+25, Oceanside separating at hinge.

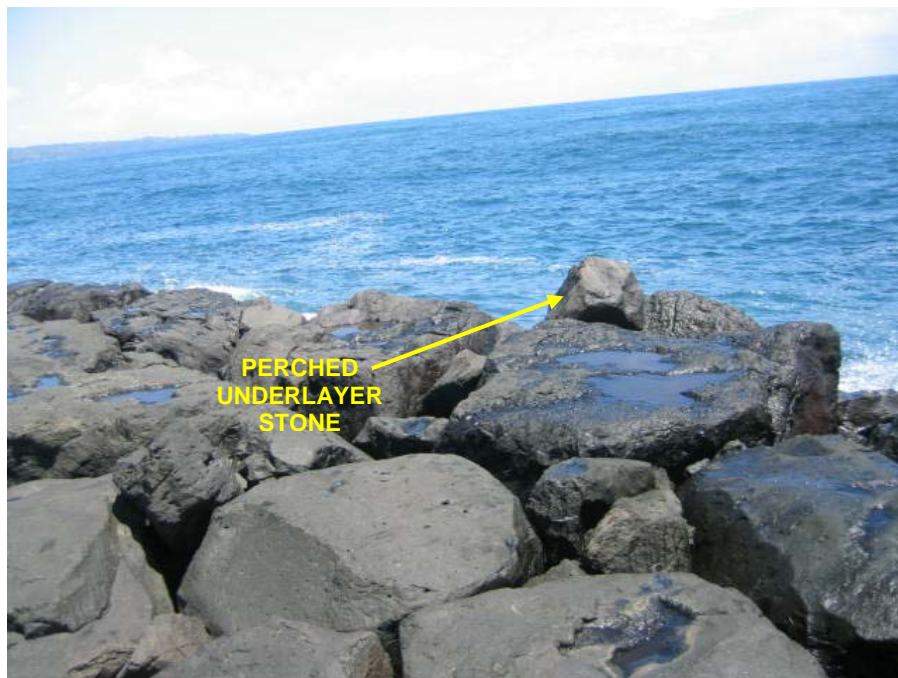
P56. Sta. 57+00, Several small underlayer stones perched on oceanside hinge.

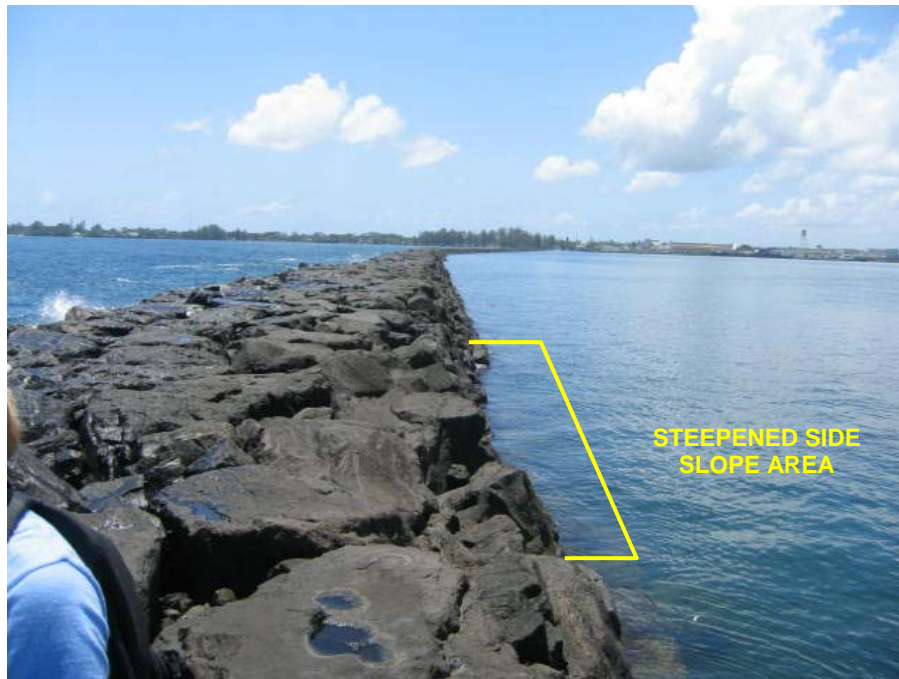
P57. Sta 57+00, Steepened harborside slope
